DEPARTMENT OF TRANSPORTATION

Quality Assurance and Source Inspection

Contract #: 04-0120F4Cty: SF/ALA Rte: 80 PM: 13.2/13.9File #: 1.28**WELDING INSPECTION REPORT****Resident Engineer:** Siegenthaler, Peter**Address:** 333 Burma Road**City:** Oakland, CA 94607**Report No:** WIR-018197**Date Inspected:** 17-Nov-2010**Project Name:** SAS Superstructure**OSM Arrival Time:** 1000**Prime Contractor:** American Bridge/Fluor Enterprises, a JV**OSM Departure Time:** 1830**Contractor:** American Bridge/Fluor Enterprises, a JV**Location:** Jobsite**CWI Name:** See below**CWI Present:** Yes No**Inspected CWI report:** Yes No N/A**Rod Oven in Use:** Yes No N/A**Electrode to specification:** Yes No N/A**Weld Procedures Followed:** Yes No N/A**Qualified Welders:** Yes No N/A**Verified Joint Fit-up:** Yes No N/A**Approved Drawings:** Yes No N/A**Approved WPS:** Yes No N/A**Delayed / Cancelled:** Yes No N/A**Bridge No:** 34-0006**Component:** SAS OBG**Summary of Items Observed:**

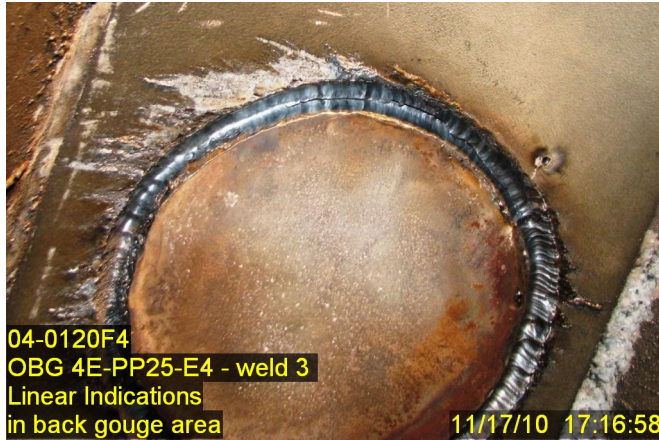
Interior: OBG 4E-PP25-E4 - welds 1 & 3

The QAI periodically observed AB/F approved welder Salvador Sandoval (ID 2202) performing air carbon arc back gouging of welds 1 & 3. The QAI was approached by QC Inspector John Pagliero while at this location. See Summary of Conversations below. The QAI obtained a photo of a linear indication in the back gouge in weld 3. See photo below. No welding was observed by the QAI at this location.

QC John Pagliero stated that the back gouges in welds 1 & 3 at 4E PP25 E4 were 7mm to 10mm deep and were full of linear indications.

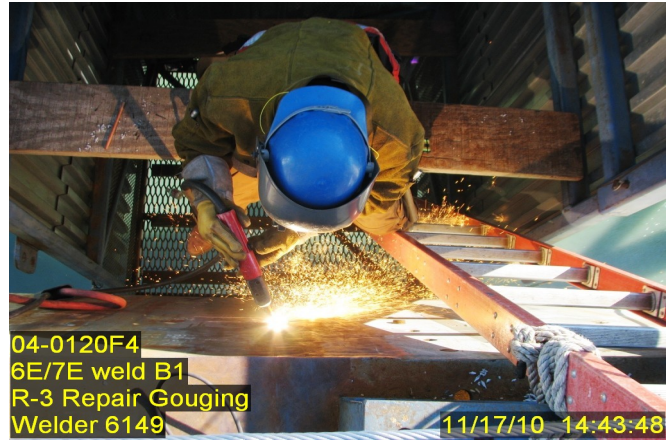
4). OBG Field Splice 6E/7E Weld ID: B1, Face A – (SMAW R-3 repair)

The QAI periodically observed AB/F approved welder Jorge Lopez (ID 6149) performing air carbon arc gouging and grinding of one R-3 repair excavation on the exterior of the splice. See photo below. The QAI observed that the location and dimensions of the excavated area were as follows: Y = 510mm, Length = 140mm, Depth = 16mm and the Width = 30mm. The QAI observed QC Inspector Tony Sherwood performing Magnetic Particle Testing (MT) of the excavated area prior to repair welding at this location. The QAI observed that the performance and evaluation of the MT appeared to comply with the MT procedure identified as SE-MT-CT-D1.5-101 Rev. 4. The QAI periodically observed repair welding per the Shielded Metal Arc Welding (SMAW) process in the 3G

(vertical) position. The QAI periodically observed QC inspector Tony Sherwood was present to monitor the progress and verify that the welding parameters were within the limits established by the approved welding Procedure Specification (WPS) identified as ABF-WPS-D1.5-1000 Repair. The work at this location was completed and appeared to be in general compliance with contract documents.
